1. REPORT NO. FHWA/CA/TL-93/09	2. GOVERNMENT ACCESSION NO.	3. RECIPIENT'S CATALOG NO.	
4. TITLE AND SUBTITLE Effects of Corrosion on the Bare Weathering Steel in the Antioch Bridge		5. REPORT DATE June 1992

6. PERFORMING ORGANIZATION CODE	
7. AUTHOR(S) Franklin O. Reed		8. PERFORMING ORGANIZATION REPORT NO. 636968	
9. PERFORMING ORGANIZATION NAME AND ADDRESS Division of New Technology, Materials and Research California Department of Transportation Sacramento, CA 95819		10. WORK UNIT NO. F83TL18

EFFECTS OF CORROSION ON THE BARE WEATHERING STEEL IN THE ANTIOCH BRIDGE

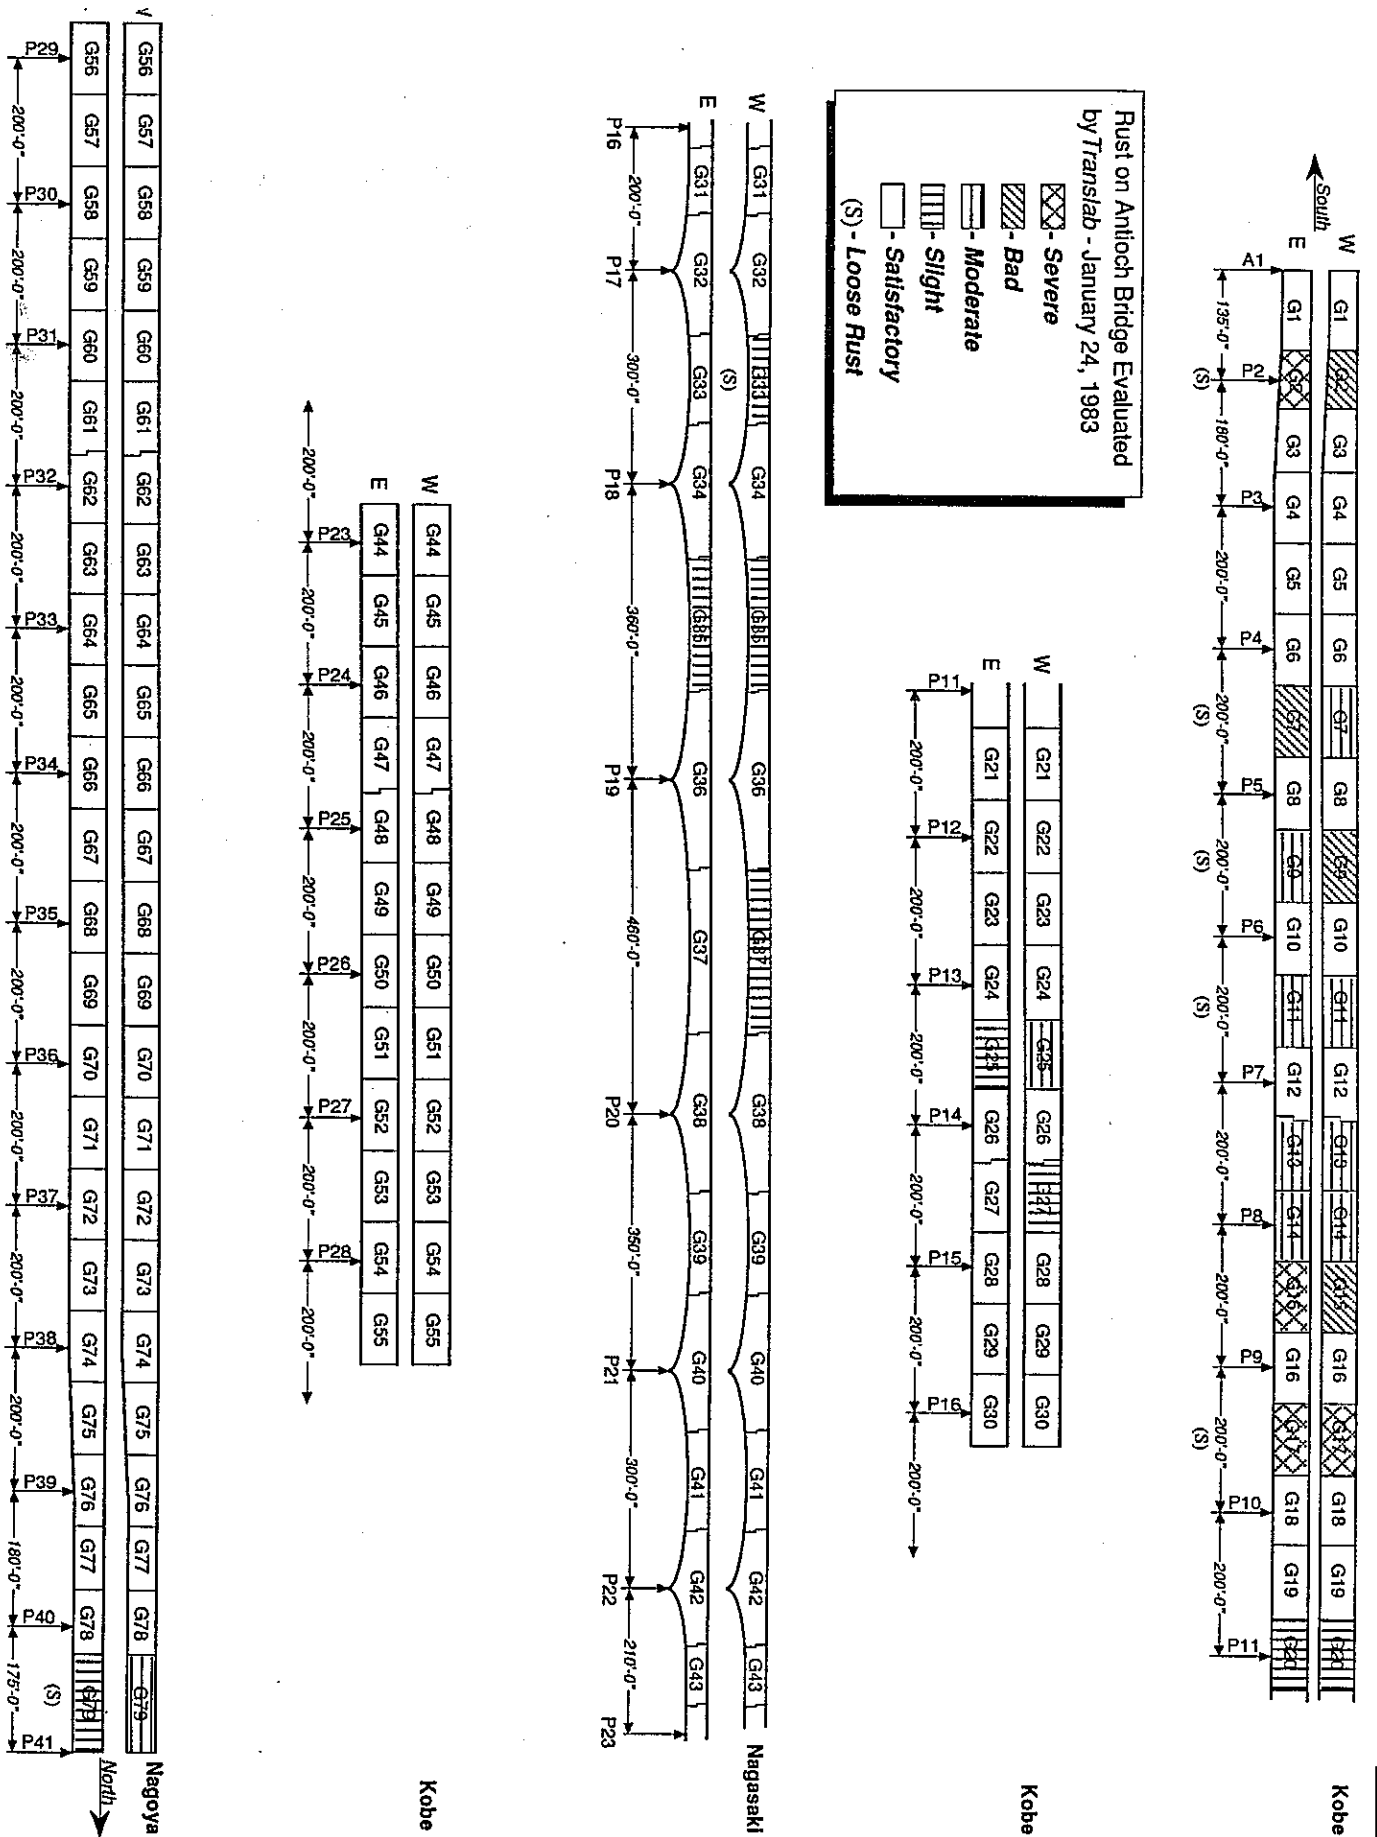
Figure 1

The Antioch Bridge girders were fabricated in three locations in Japan - Kobe, Nagasaki and Nagoya. All three locations are subject to chloride contamination from salt air. However, Nagasaki has the most severe environmental conditions for chloride contamination and high humidity because of its location at the extreme Southern part of Japan which is completely surrounded by sea water. As indicated in figure 1, girders G31 through G43 were fabricated in Nagasaki.

Initial observations as indicated in figure 1, were that there were areas that appeared to not be stabilizing. These areas have a good correlation with members that were shipped above deck indicating that the salt contamination from the ocean spray had a significant role in the continuing corrosion. Recent observations reveal that some areas such as the undersides of flanges and corners between top flanges and webs where water condenses are still flaking as can be seen in figure 9.

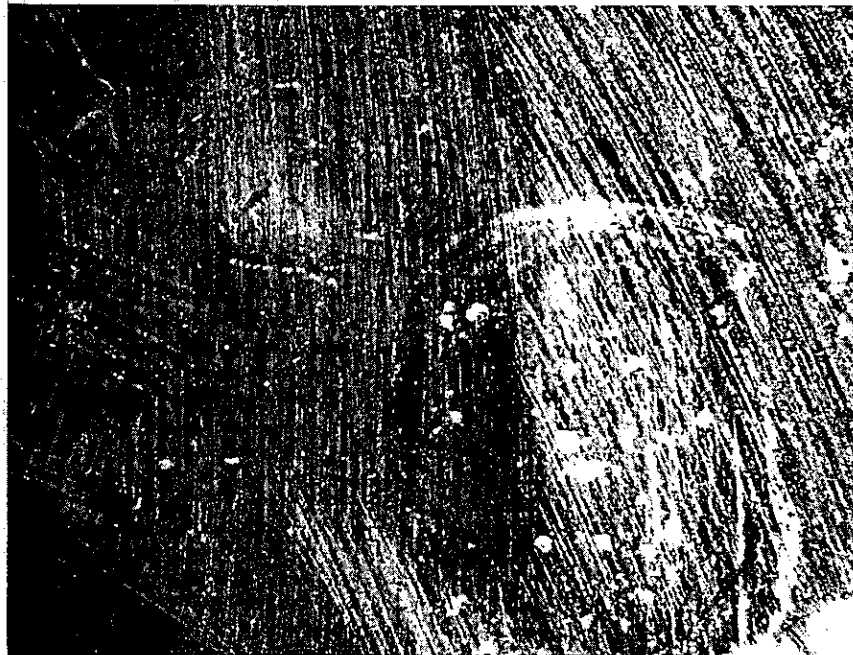
Figure 4 is the surface of GL 35-3-3 after grinding off approximately 4 mils. The light areas are pits remaining. It required grinding off 7 mils before all of the pits were ground out indicating a maximum pit depth of 7 mils.

GL 35-3-3 Shows pits Remaining After Removing 4 mils By Grinding

The difference between this maximum pit depth and that obtained by depth measuring microscope is that it is practically impossible to remove all of the rust products from the bottom of the pits.

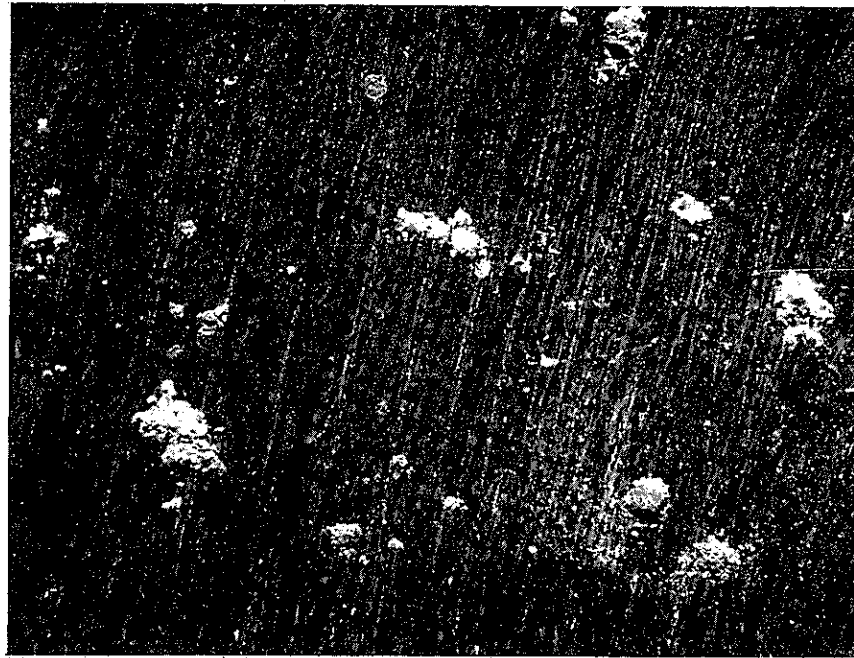
Figure 5 is a photo of the surface of plaque GL 39-2-7 after grinding off 7 mils. The light areas show remaining pits.

GL 39-2-7 Pits remaining After Grinding Off 7 Mils

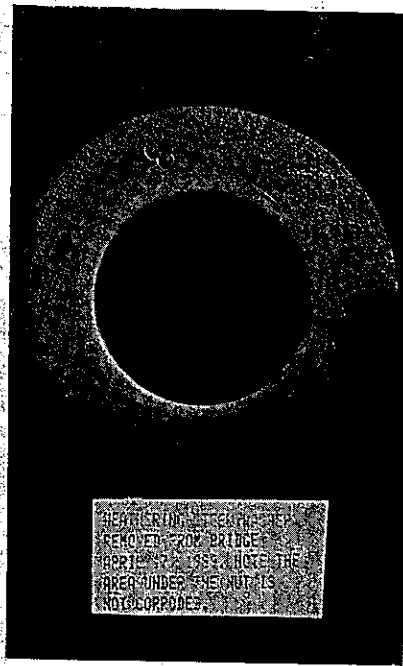
Figure 6

The washer shown in figure 6 is pitted around the outer edge and shows little pitting in the area that was under the nut. The average pit depth in the pitted area is 0.0027 inch. This would be approximately 0.22 mils/year.

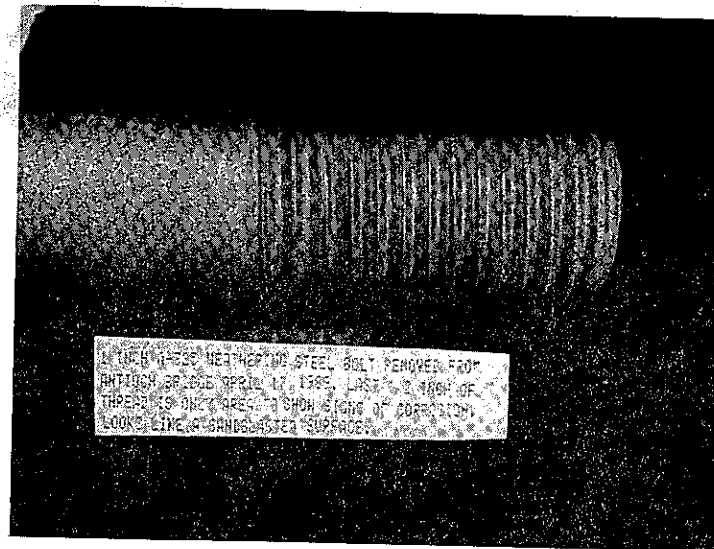
Figure 7

The bolt shown in figure 7 is pitted on the exposed threaded end and had an average pit depth of 0.0033 inch in the pitted area for an average of 0.28 mils/year.

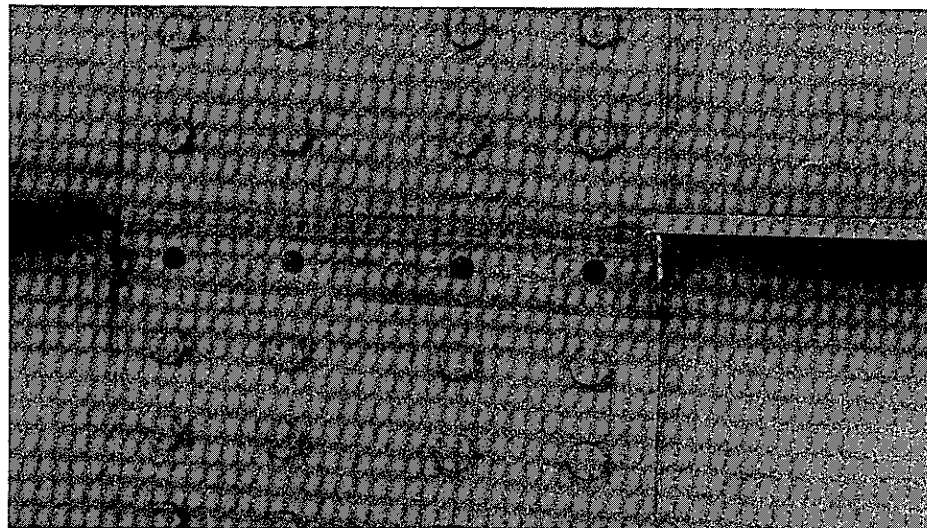
The area where the bent stiffener splice plate and the girder splice plate come together shows active corrosion on both the girder splice plate and the stiffener splice plate. The bent plate provides a receptacle for debris of all kinds which tends to hold moisture. Figure 8 is a view of the girder splice plate with the stiffener splice plate removed.
